Canadian Utility Initiates Trial Evaluation of Composite Transmission Poles

INMR first reported on the problem in the Q1, 2017 issue with an article discussing how one Canadian utility was assessing the situation and how best to respond. This follow-up article discusses progress on a trial evaluation of one of the measures identified to resolve woodpecker damage.

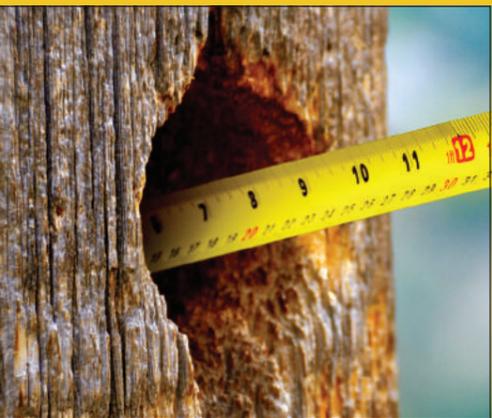
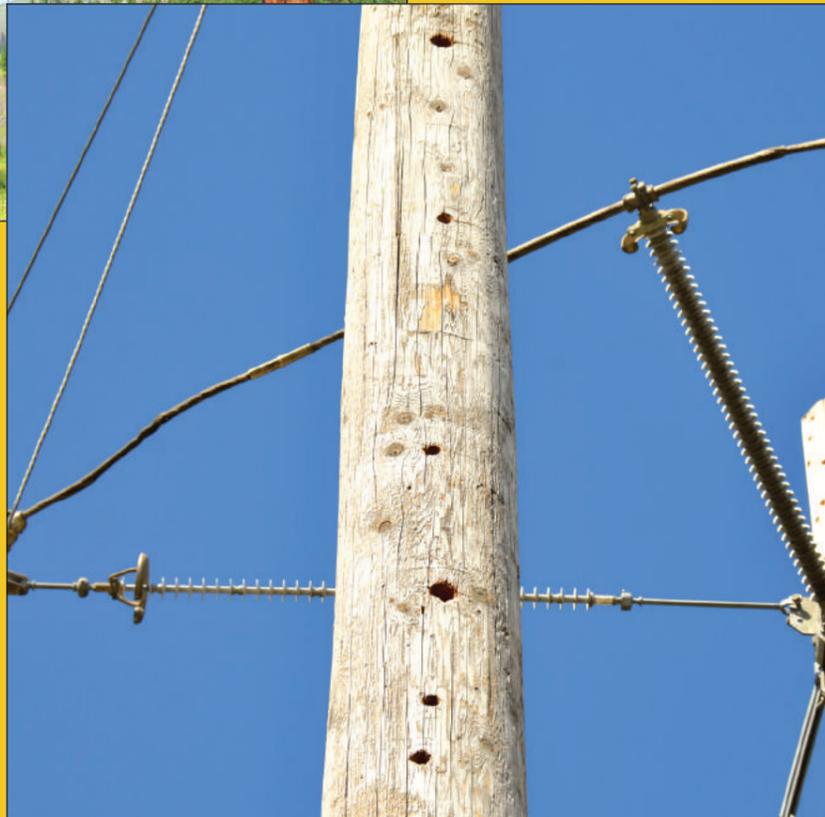
Impact of certain species of woodpecker on wood framing presents a serious asset management challenge to utilities.

Wood pole framing is common on transmission networks throughout North America and indeed across the globe. However, while the typical service life of such poles is normally between 50 and 60 years, damage caused by various species of woodpeckers has, in extreme cases, required these structures be replaced in only a fraction that time. Moreover, poles in affected line corridors may also need more frequent inspection since incidence of hole pecking occurs over a narrower time frame than most other problems. All this has made the activity of these birds a growing asset management challenge.

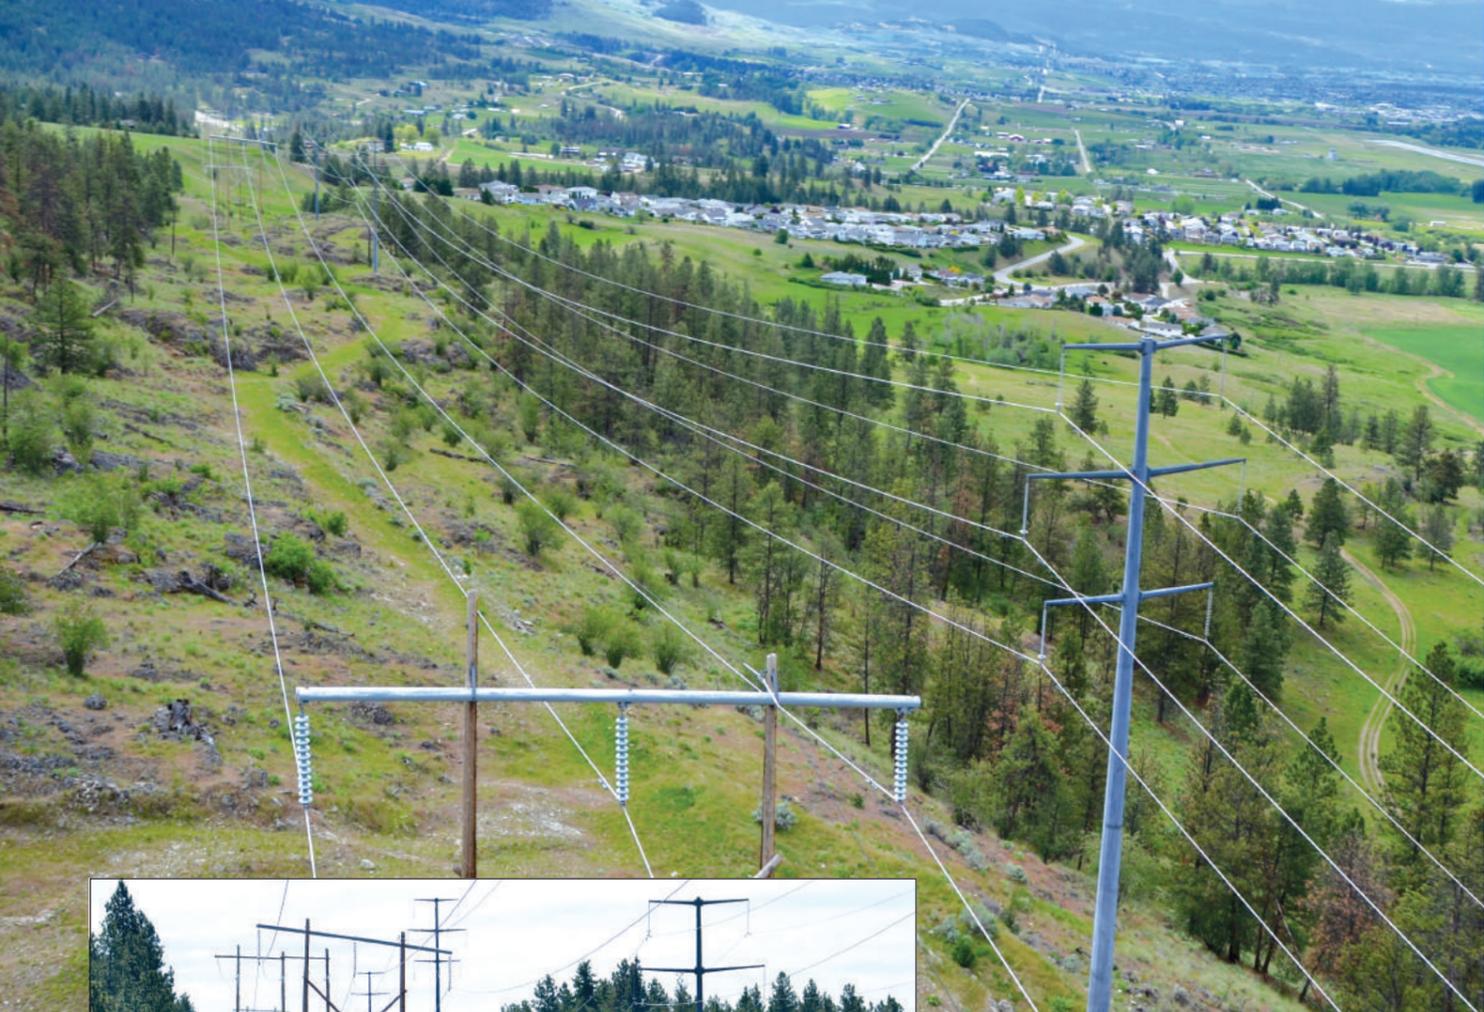
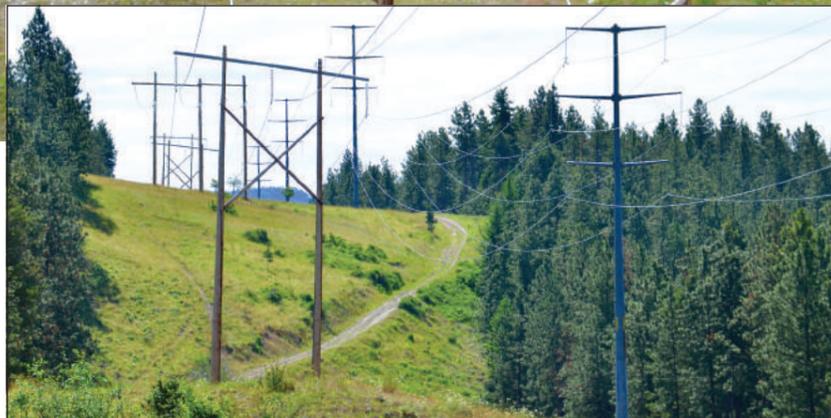
230 kV line (left) running from Lee Substation in Kelowna to Vernon has suffered woodpecker damage to some poles and was selected to test new composite pole.

Nevertheless, Khalil-Pour and Operations Manager, Tom Harrison, feel that composite poles offer an effective solution for high problem areas, looked at on a case-by-case basis. With all these considerations in mind, engineers selected a 230 kV transmission line that is among those most affected by woodpeckers. The line runs through a hilly corridor bordering lakes and sparse pine forest. One specific structure was identified and this past June its wood framing was replaced by composite fiberglass poles and cross-braces.

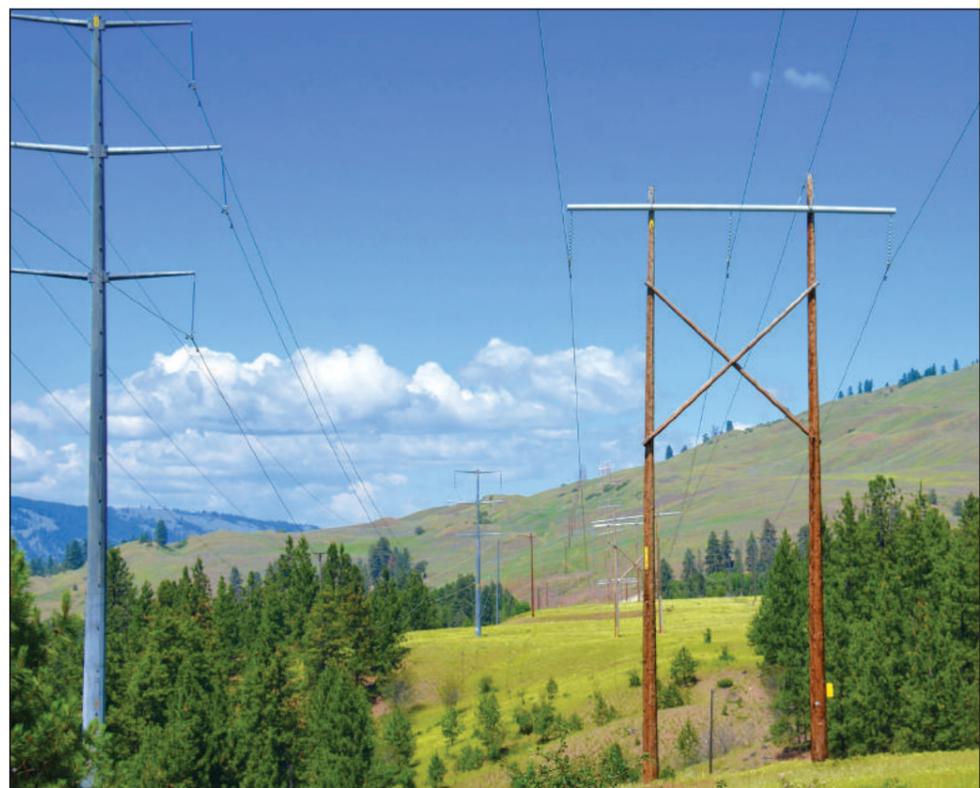
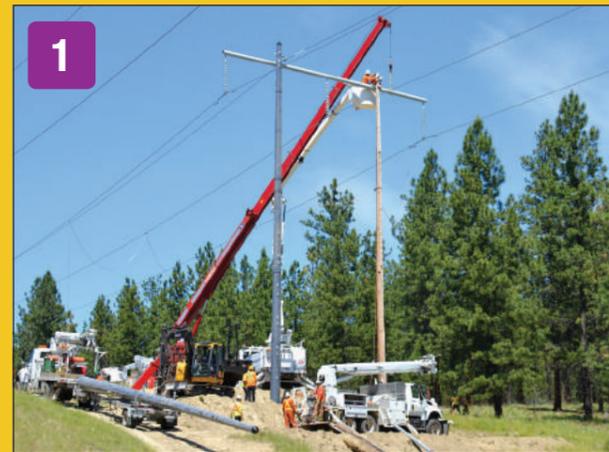
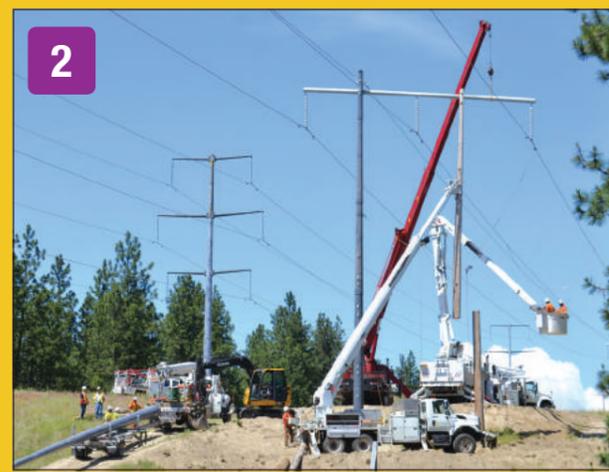
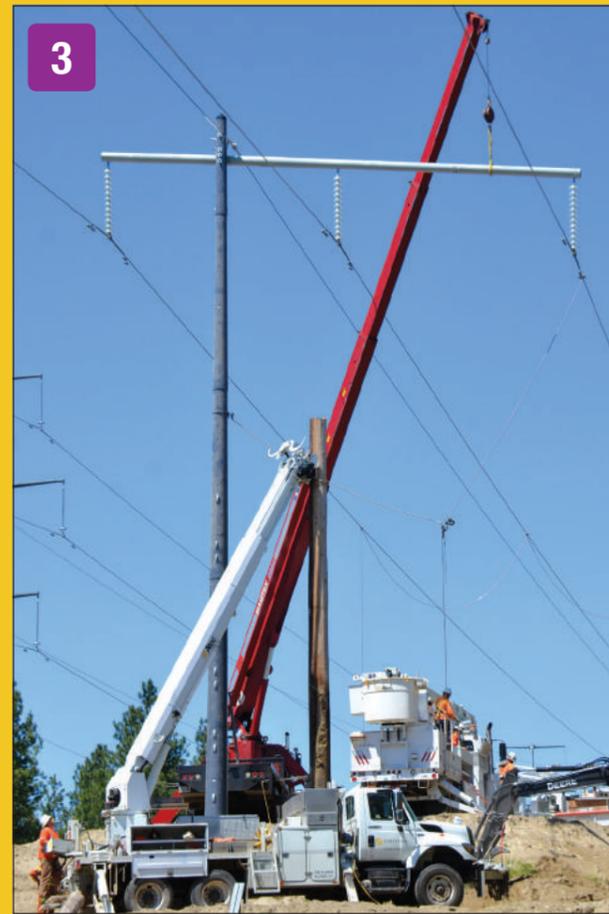
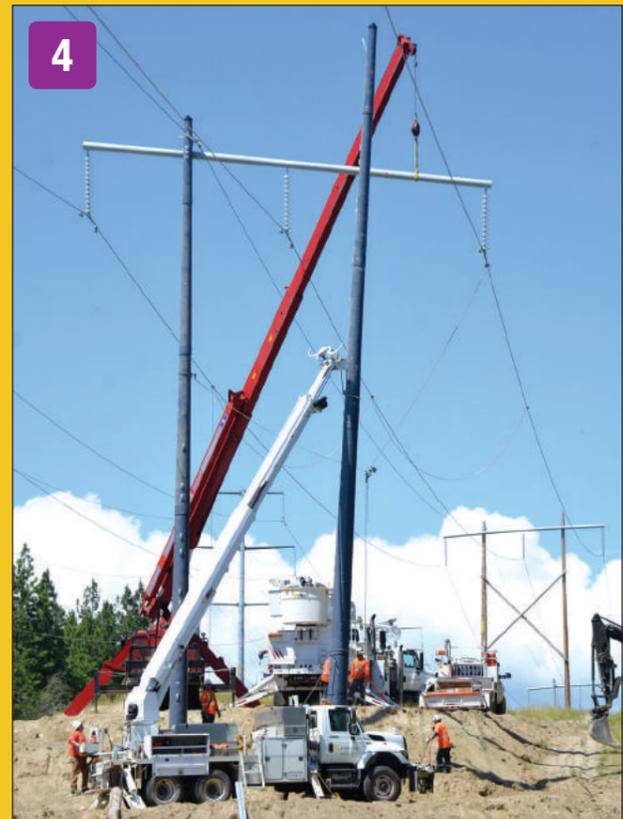
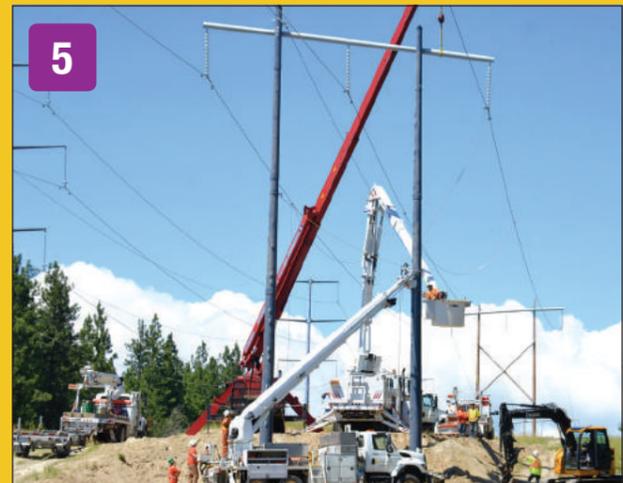
Process to replace wood framing with composite poles.

Khalil-Pour states that the focus for the time being is mainly on field experience when it comes to replacing wood framing with composite poles using established construction procedures. Among the main factors in this regard is how well current construction procedures are able to adapt to the requirements of the new structures. For example, like wood framing, composite poles do not require spec-

ial civil engineering to prepare foundations and are simply buried in place. A related issue, he notes, is feedback from crews on how easy these poles are in terms of handling and drilling.

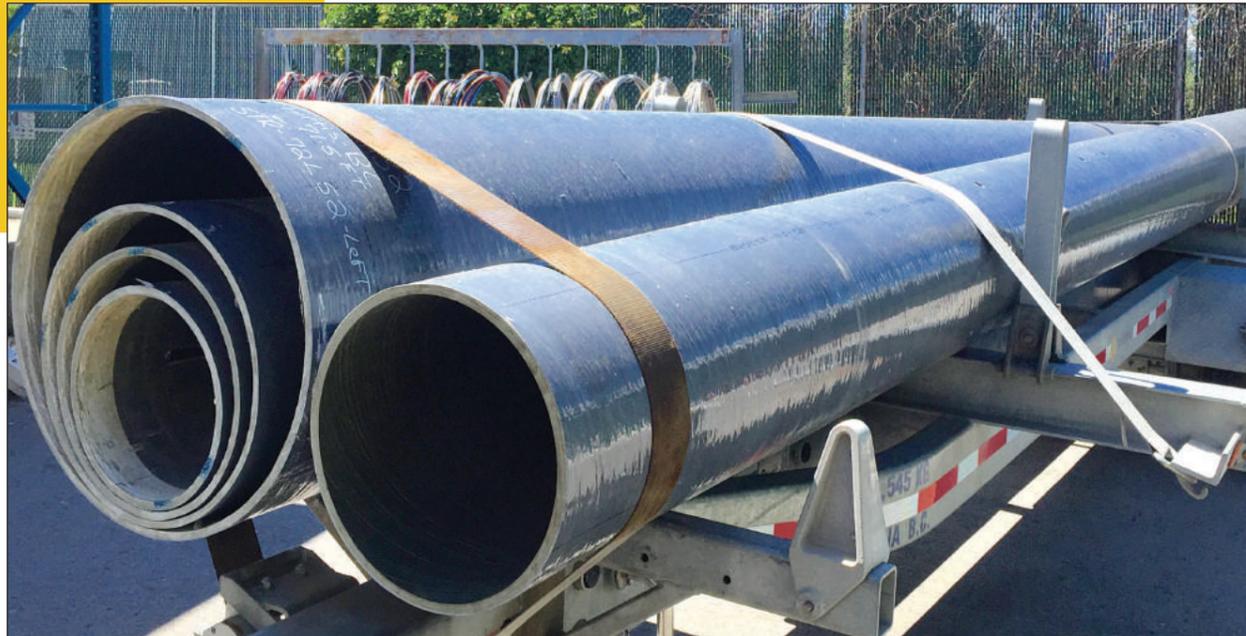
Composite poles supplied such that narrower sections fit inside wider sections, for easier storage and handling.

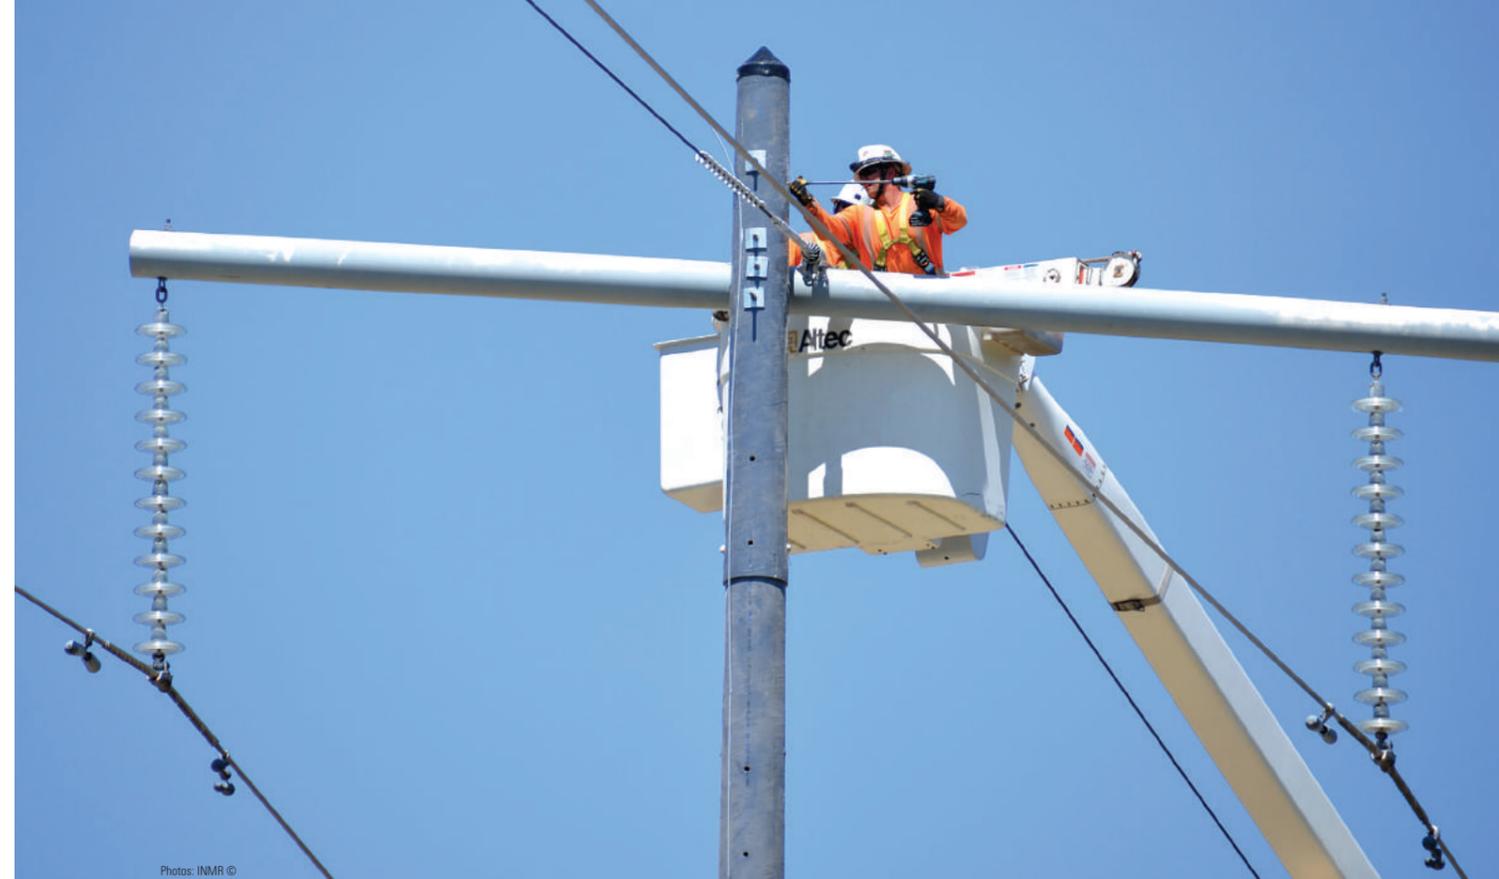
One of the issues of concern to FortisBC engineering staff is how 'friendly' composite poles are to drilling.
